# New York State Department of Transportation

## Yellow Flag NB2228W012

**BIN: 1065318**

Location: Span 119 Girder G13 at Pier 118

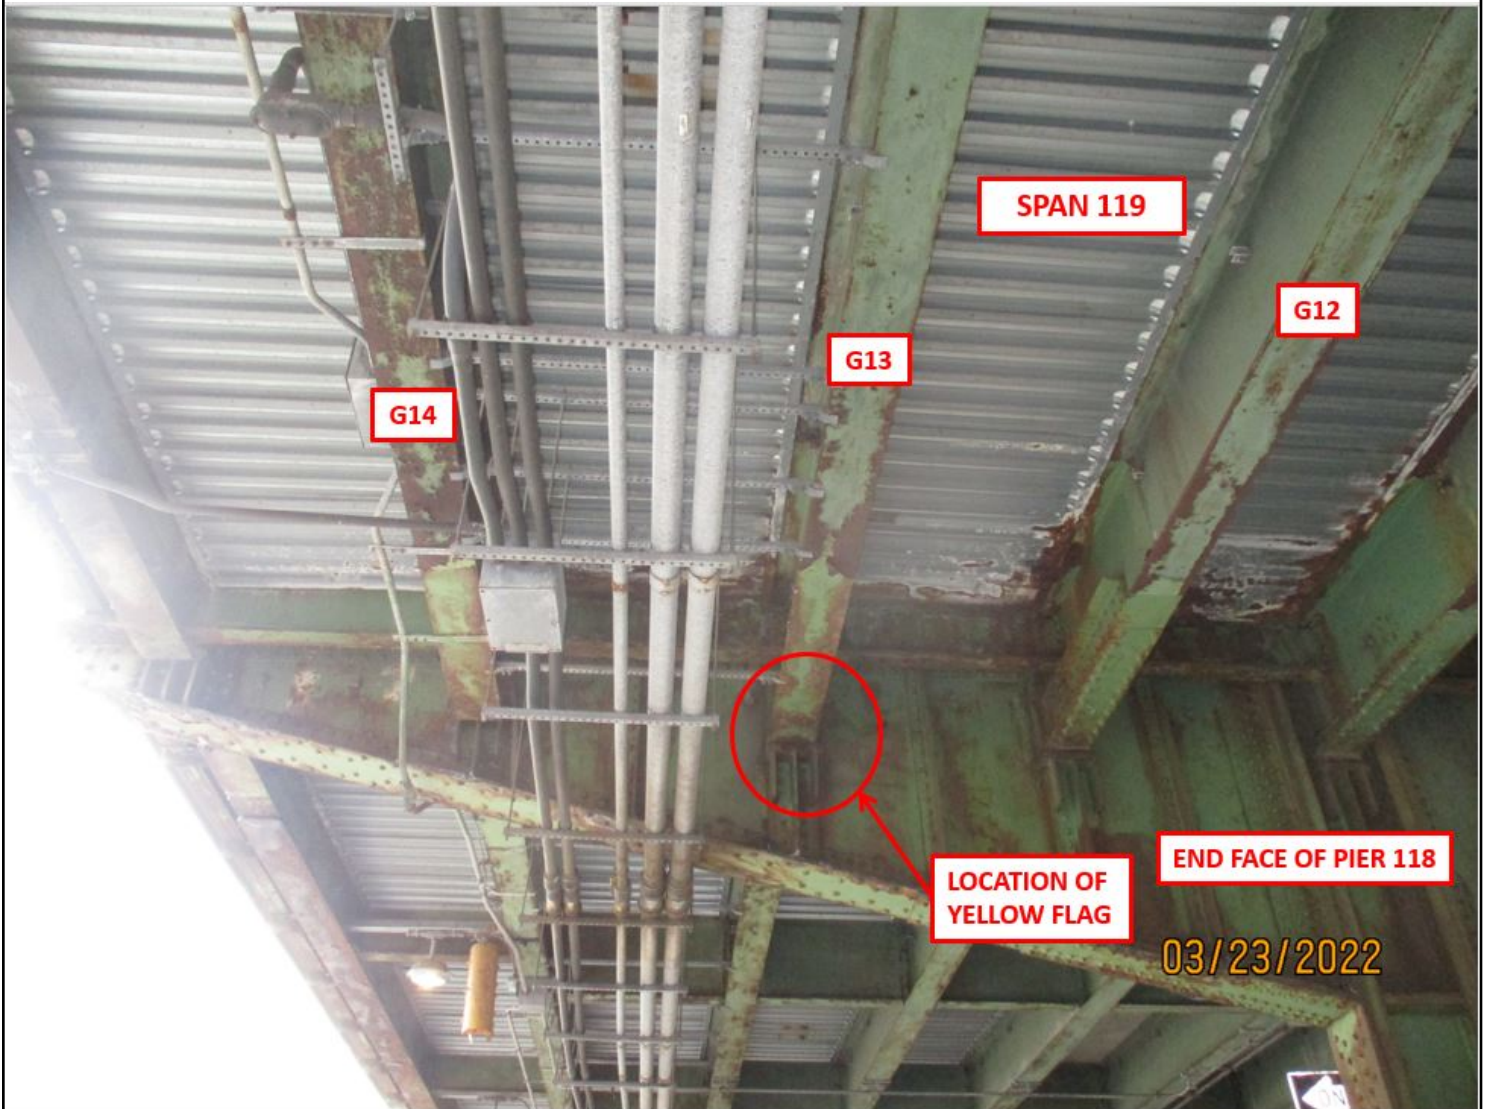
Photo Number: 1

Description: The end of Girder G13 in Span 119 at Pier 118 exhibits severe corrosion resulting in an overall web bearing area section loss of approximately 45% (previously 40%) and an overall shear web area section loss of approximately 65% (previously 64%, no significant change) with an overall localized section loss of approximately 38% (previously 32%) for 5"L x 6"H area directly above the bearing below the guide angle (Photos 2 and 4). This is a small increase in section loss due to a change in dimensions. The end of the girder web exhibits 13"L x 1"W corrosion hole approximately 7" from the bottom flange (Photo 3). Also, the lower web of the girder adjacent to the web bearing area exhibits average section loss up to 30% for 18"L x 3"H above the bottom flange. (Refer to sketch for more details)

**Attachment Description:** General view of the flagged condition at Girder G13 in Span 119 at Pier 118. Looking Begin.

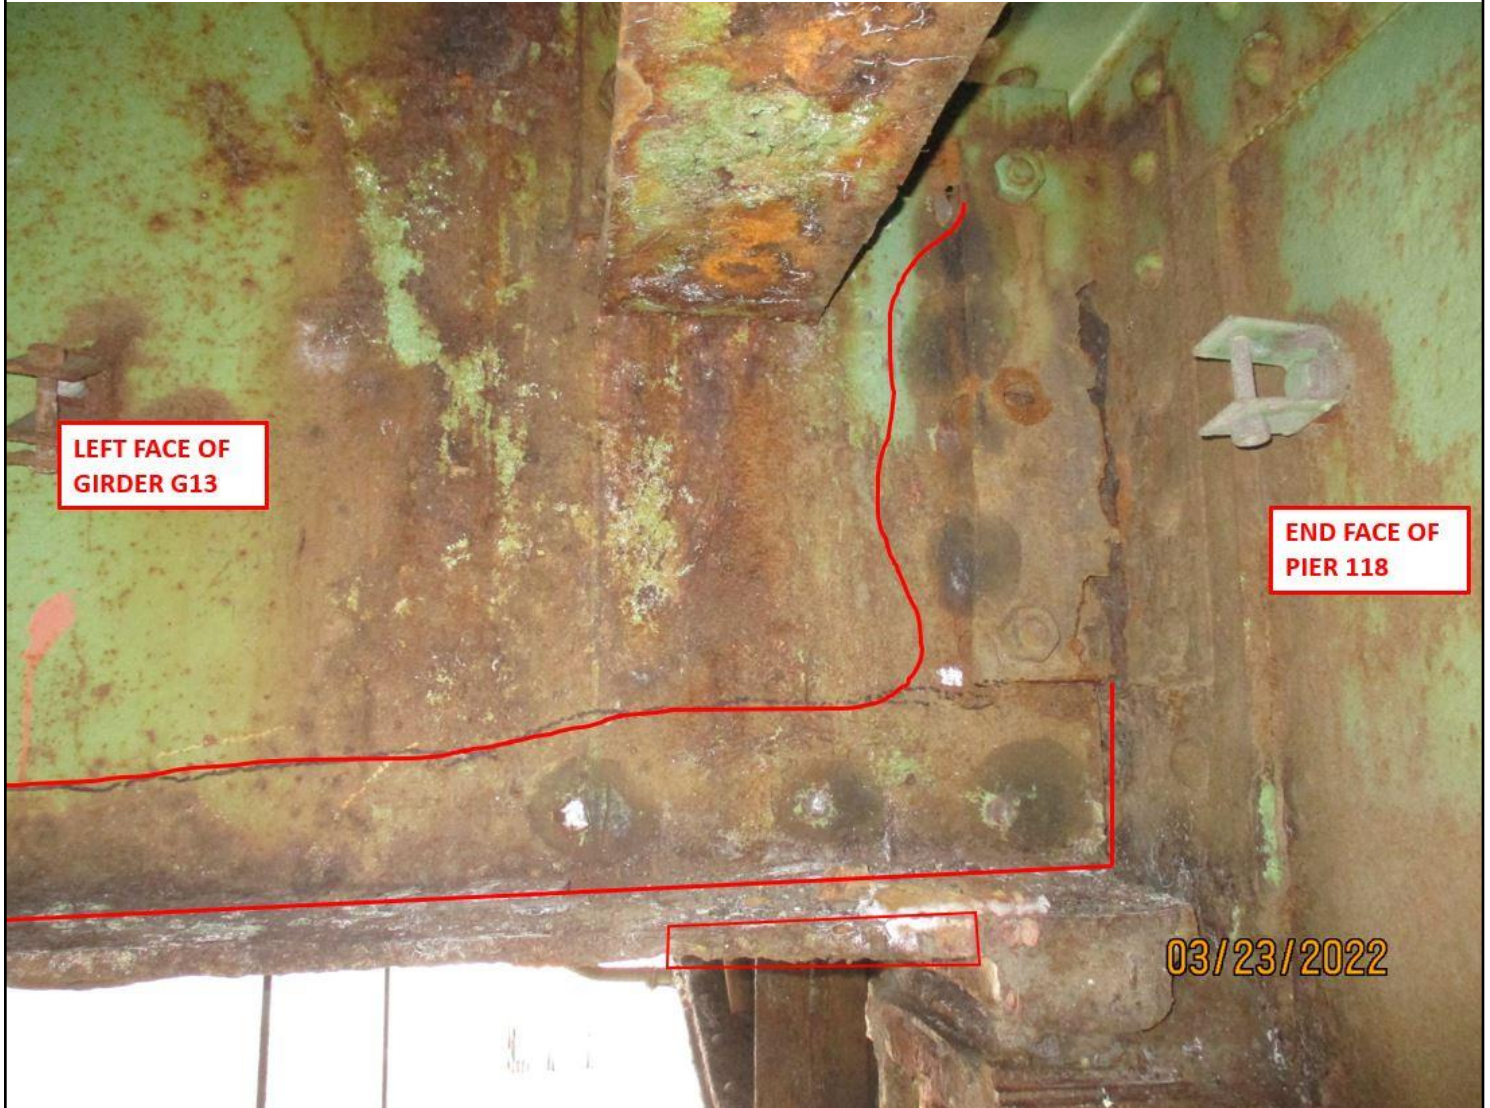
Photo Number: 2

**Attachment Description:** The left face of Girder G13 in Span 119 at Pier 118. The end of the girder exhibits severe section loss at the lower web above the bottom flange and web adjacent to the guide angle. Looking Right.

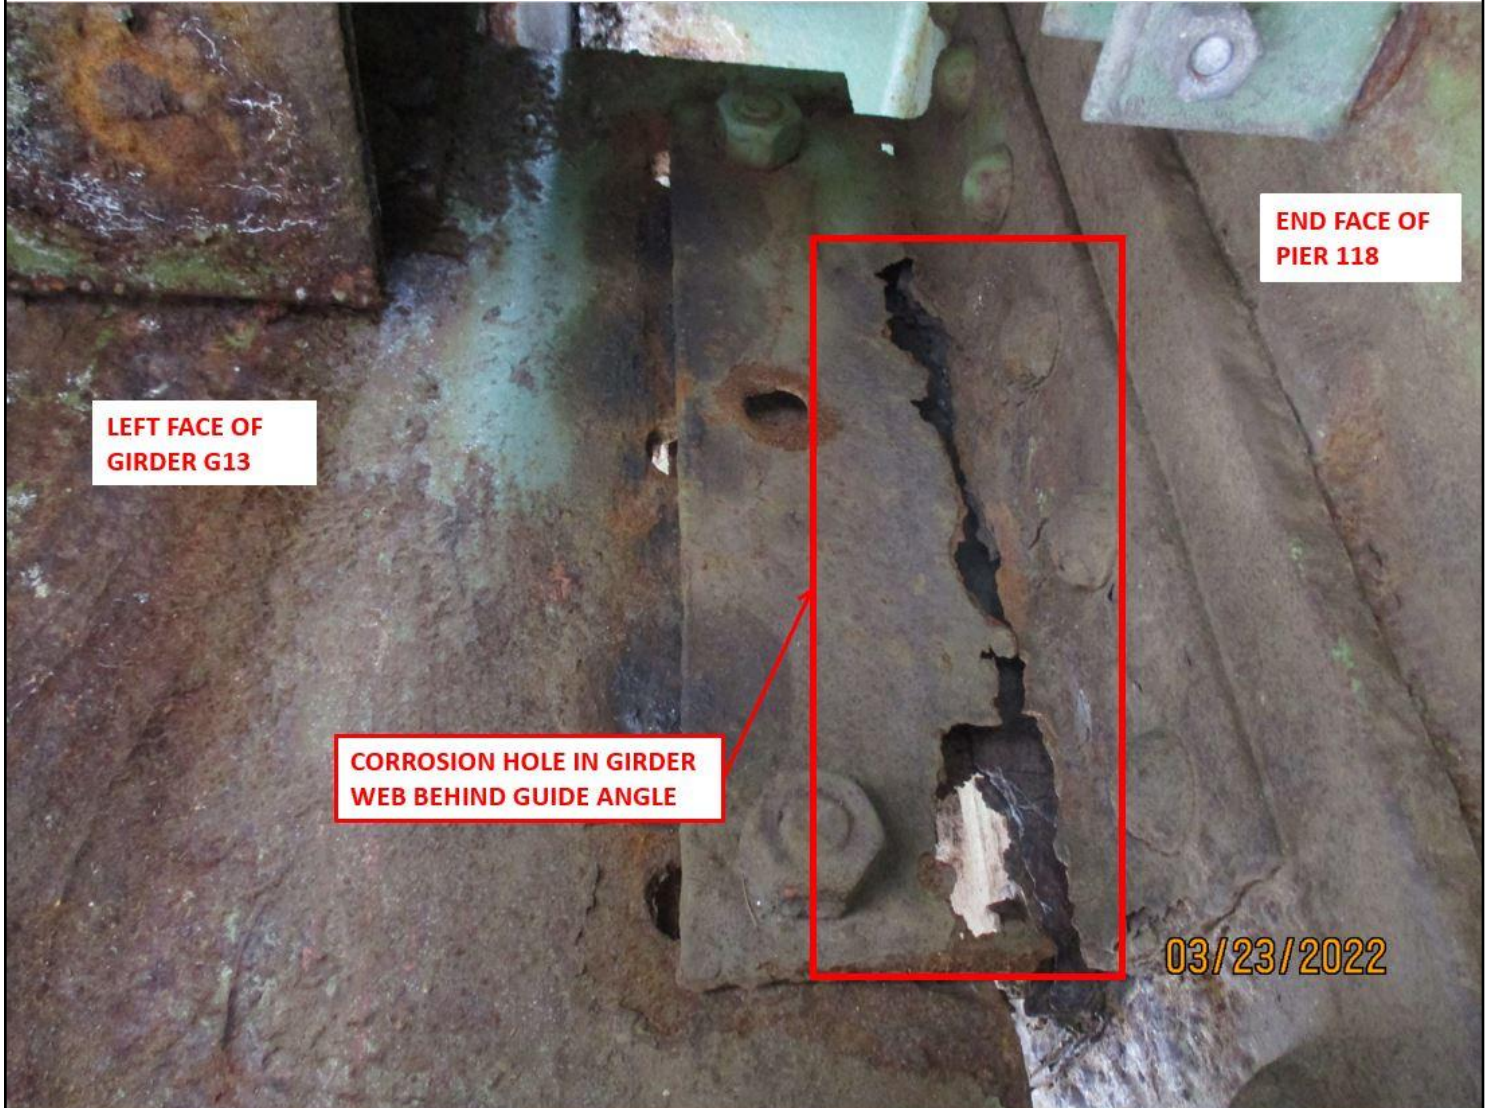
**Attachment Description:** The left face of Girder G13 in Span 119 at Pier 118. The end of the girder web exhibits a corrosion hole behind the guide angle. Looking Right.

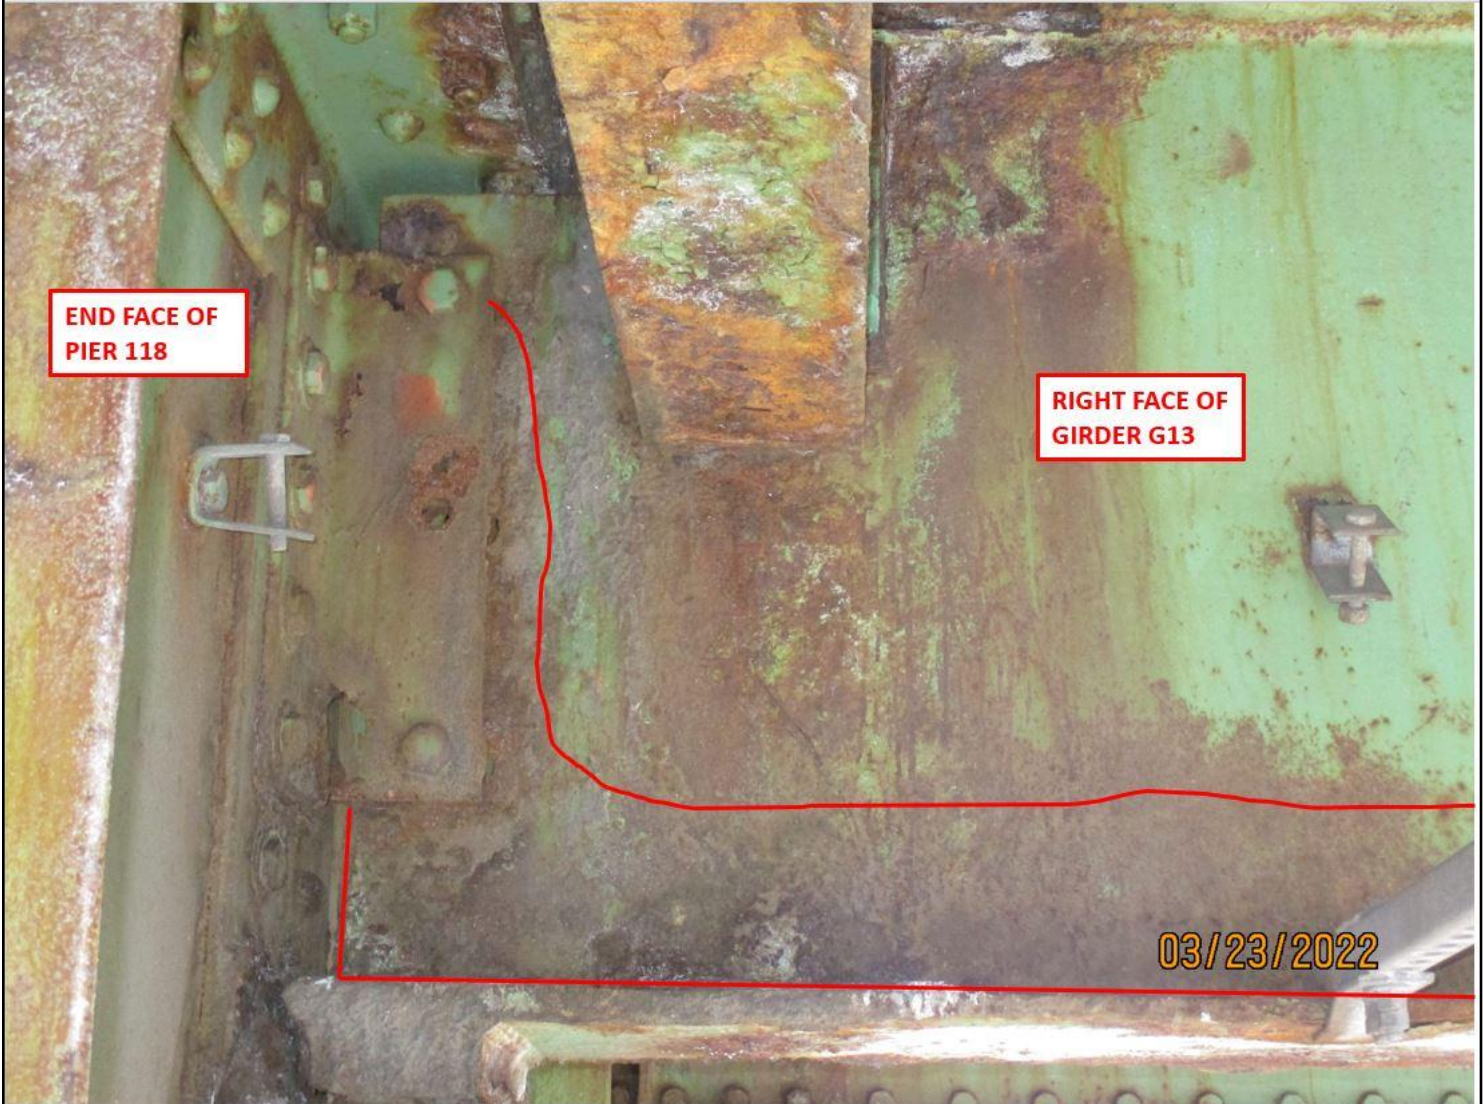
Photo Number: 4

**Attachment Description:** The right face of Girder G13 in Span 119 at Pier 118. The end of the girder exhibits severe section loss at the lower web above the bottom flange and web adjacent to the guide angle. Looking Left.

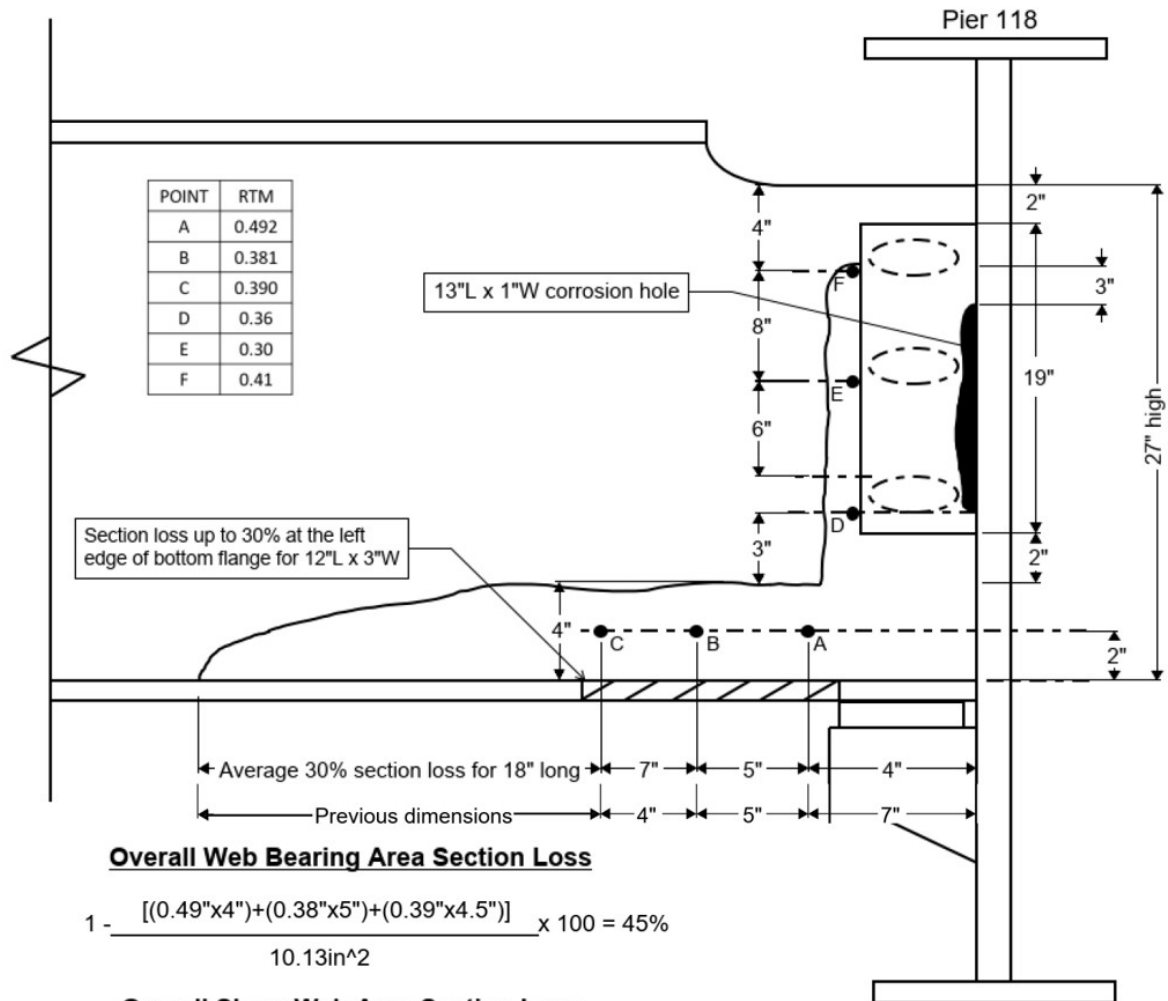
**Left Face of Girder G13 Sketch in Span 119 at Pier 118**

- As-built web thickness = 0.75"
- Length of bearing area = 18 x web thickness = 18 x 0.75" = 13.50"
- Overall bearing area = 13.50" x 0.75" = 10.13 in<sup>2</sup>
- As-built shearing web area = 27" x 0.75" = 20.25 in<sup>2</sup>
- Adjacent Girder G12 has previously installed steel reinforcement plates and angles at the end of the girder.
- Adjacent Girder G14 exhibits up to 25% localized section loss in the lower web above the bottom flange in front of the bearing.
- Left guide angle at Girder G13 exhibits 13"L x up to 2"W corrosion hole starting at the bottom of the angle. This defect was not shown in the sketch for clarity purposes to display girder defects.

**Attachment Description: Sketch of Span 119 Girder G13 at Pier 118**
